**Flood Control Project Maintenance
Levee Inspections**

2011 Channel Summary Report

Merced Streams Group

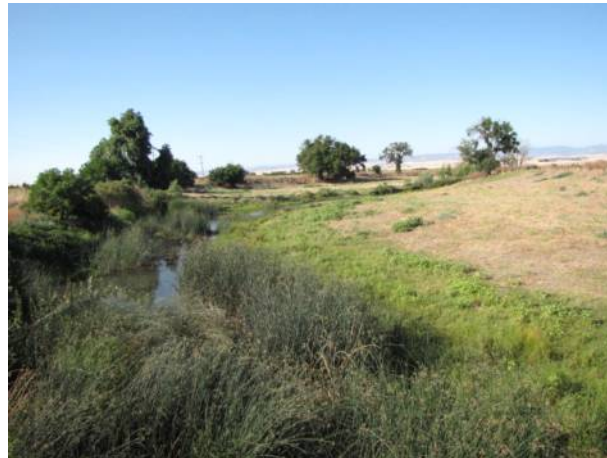
phillips_c_20110819_089.jpg

Bonner Rd crossing the Bear Creek. Looking upstream from the bridge, tullies present in channel. Photo taken 7-19-2011.

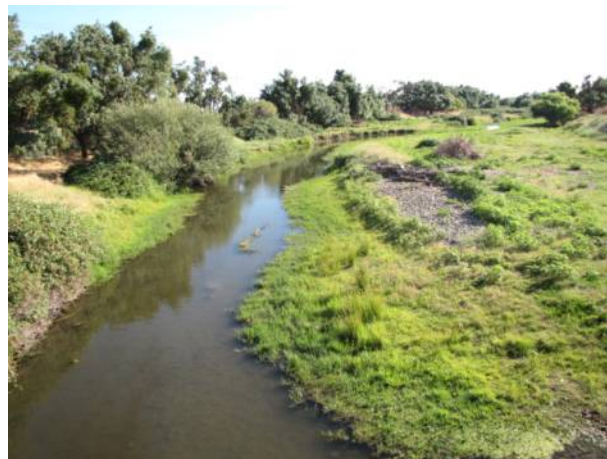
phillips_c_20110819_090.jpg

Bonner Road crossing the Bear Creek looking downstream at the pilot channel from the bridge. Photo taken 7-19-2011.

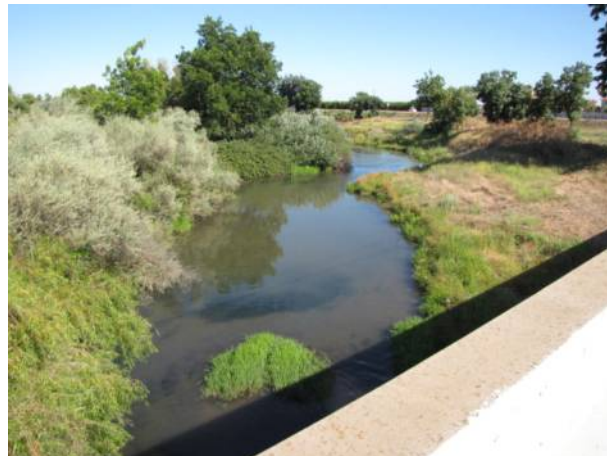
phillips_c_20110823_091.jpg

Arboleda Dr. crossing Bear Creek looking upstream. Photo 7-19-2011

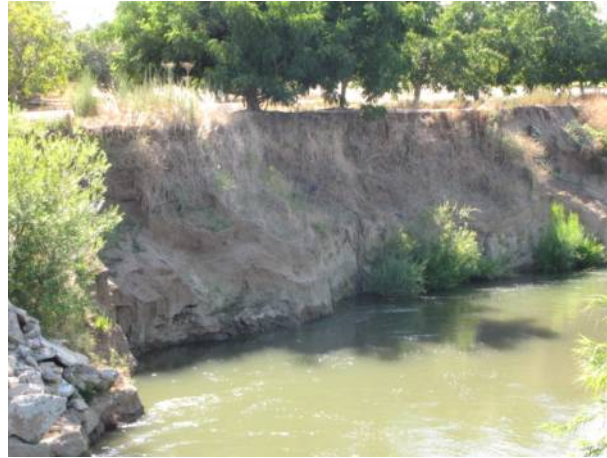
Levee Mile Report Line	28
Start Levee Mile	0.00
End Levee Mile	0.00
Location	
Category	Channels
Item	Erosion / Bank Caving
Looking on left bank facing downstream erosion exist downstream from rock protection. Photo taken 7-19-2011.	
phillips_c_20110829_095.jpg

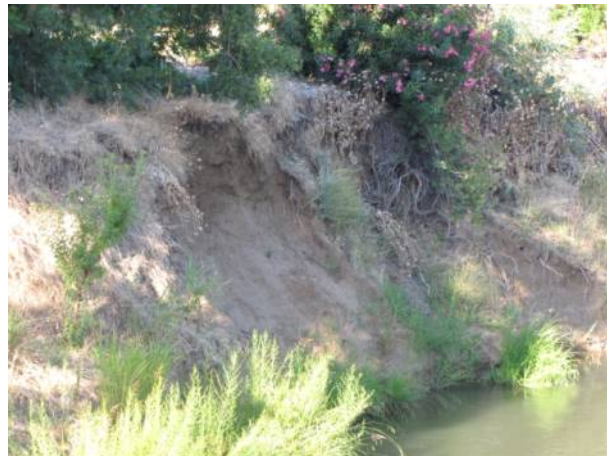
Levee Mile Report Line	33
Start Levee Mile	0.00
End Levee Mile	0.00
Location	
Category	Channels
Item	Erosion / Bank Caving
Erosion on right bank upstream of McKee Rd crossing the Bear Creek.	
phillips_c_20110829_098.jpg

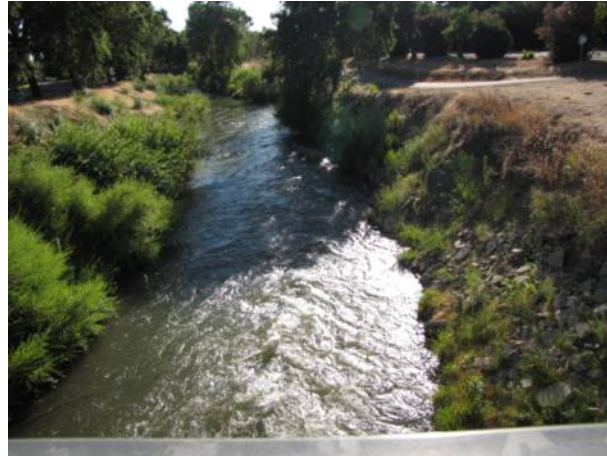
phillips_c_20110829_097.jpg

McKee Rd crossing the Bear Creek looking downstream . Photo taken 7-19-2011.

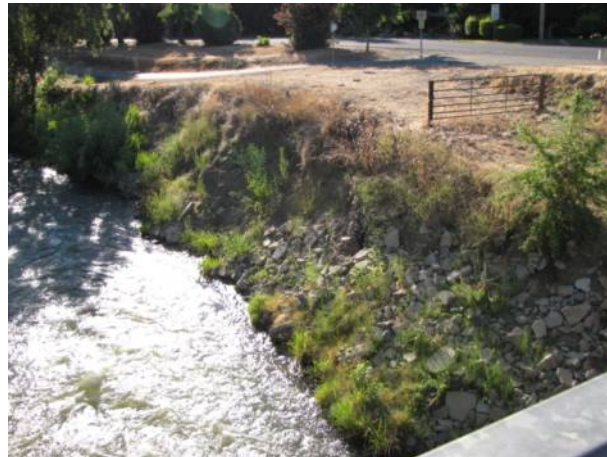
phillips_c_20110829_099.jpg

Looking downstream from McKee Rd crossing erosion present on the right bank. This photo was taken 7-19-2011.

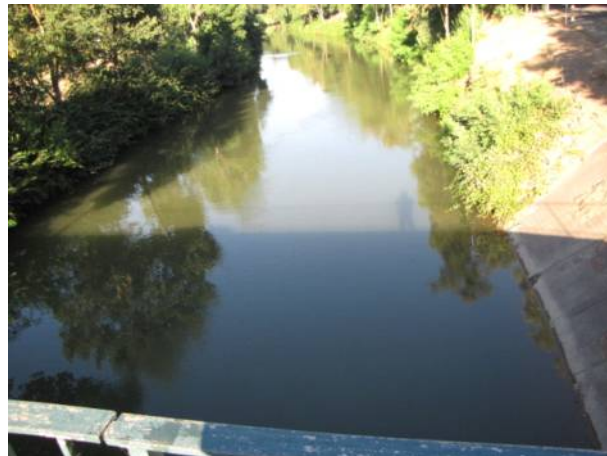
phillips_c_20110830_100.jpg

R Street crossing the Bear Creek looking back upstream along the bike trail left bank. Photo taken 7-19-2011

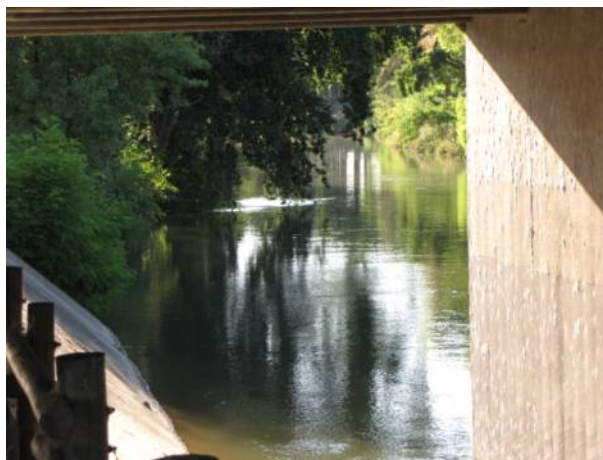
phillips_c_20110830_102.jpg

Standing under R street Bridge looking downstream. This photo was taken 7-19-2011.

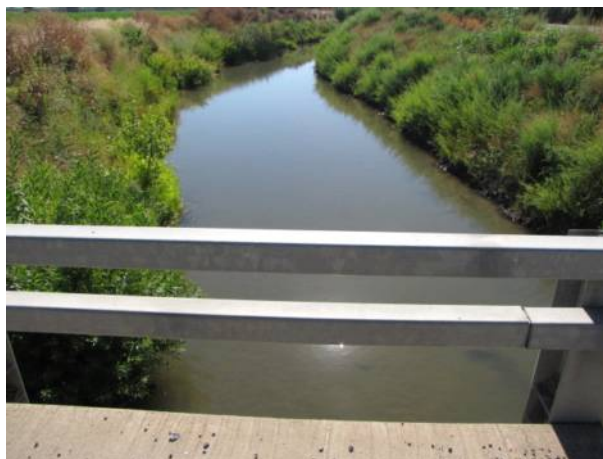
phillips_c_20110830_103.jpg

Standing on Franklin Rd. crossing the Bear Creek. This photo taken 7-20-2011.

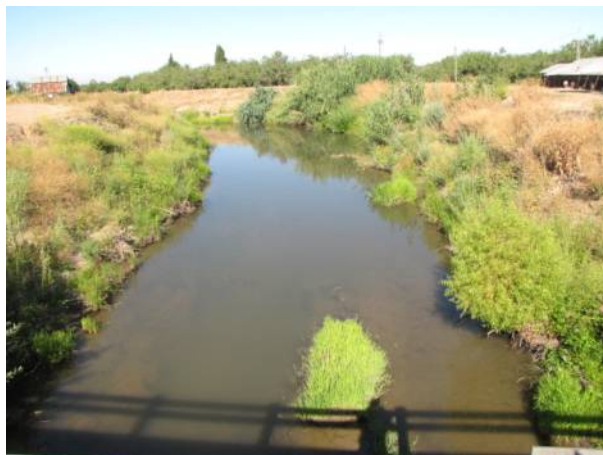
phillips_c_20110830_105.jpg

Franklin Rd. crossing the Bear Creek facing downstream. This photo taken 7-20-2011.

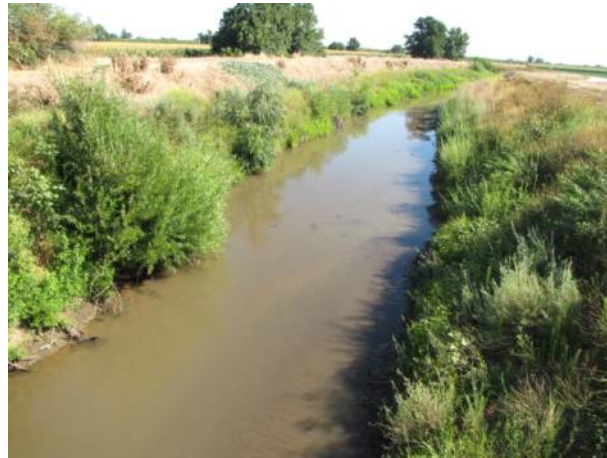
Levee Mile Report Line	61
Start Levee Mile	0.00
End Levee Mile	0.00
Location	
Category	Channels
Item	Vegetation & Obstructions
Hwy 140 Rd. crossing the Bear Creek facing upstream. Photo taken 7-20-2011.	
phillips_c_20110830_106.jpg

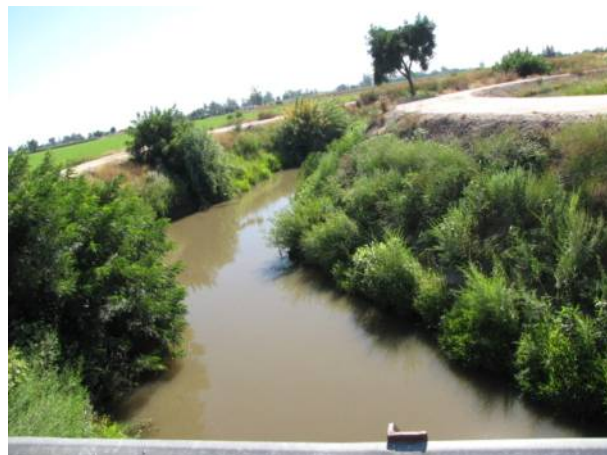
Levee Mile Report Line	71
Start Levee Mile	0.00
End Levee Mile	0.00
Location	
Category	Channels
Item	Vegetation & Obstructions
Buhach Rd. crossing Bear Creek facing upstream. Both banks are covered with growth. Photo taken 7-20-2011.	
phillips_c_20110831_108.jpg

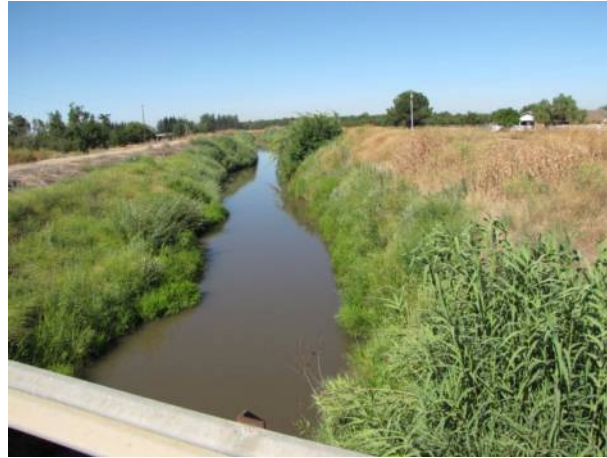
Levee Mile Report Line	76
Start Levee Mile	0.00
End Levee Mile	0.00
Location	
Category	Channels
Item	Vegetation & Obstructions
Buhach Rd. crossing the Bear Creek facing downstream. Photo taken 7-20-2011.	
phillips_c_20110831_109.jpg

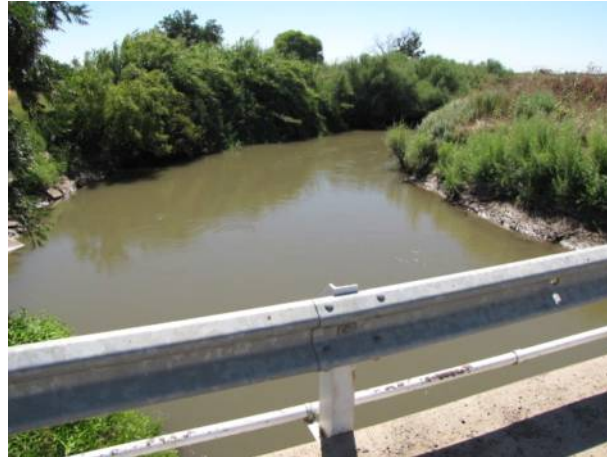
phillips_c_20110831_114.jpg

Bert Crane Rd. crossing the Bear Creek looking upstream at channel. Photo taken 7-20-2011.

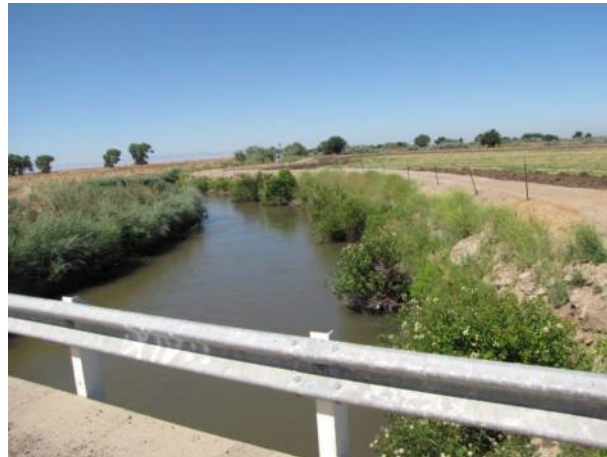
phillips_c_20110831_115.jpg

Bert Crane Rd. Crossing the Bear Creek looking downstream. Photo taken 7-20-2011.

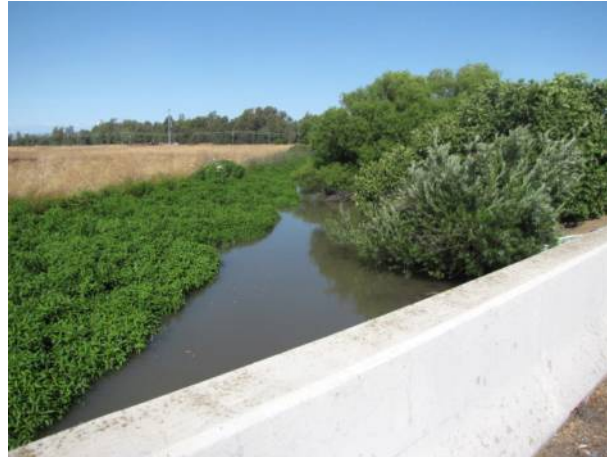
phillips_c_20110713_001.jpg

Standing on Santa Fe Drive looking up stream at BlackRascal Creek, wild growth present on both banks and in channel. Photo taken 7-13-2011.

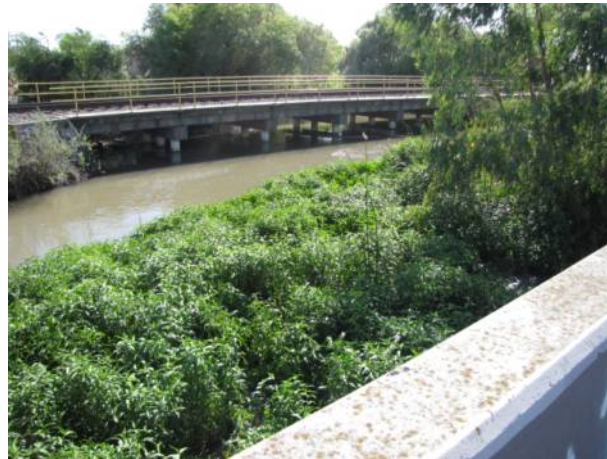
phillips_c_20110713_002.jpg

Looking downstream at wild growth on rightbank BlackRascal Creek. Photo taken 7-13-2011.

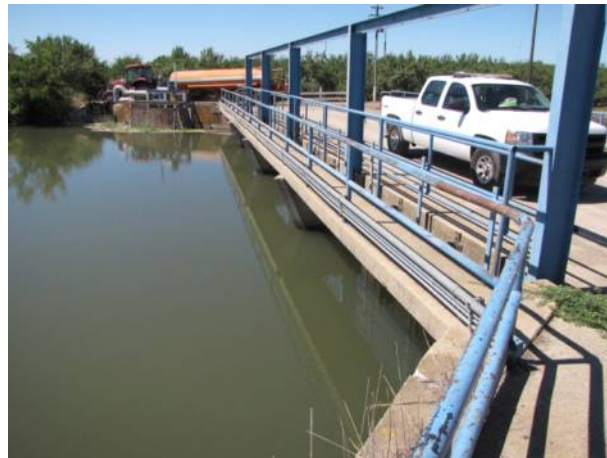
phillips_c_20110718_003.jpg

Standing on upstream right bank of Crocker Dam crossing on the Black Rascal Creek. This photo was taken 7-13-2011.

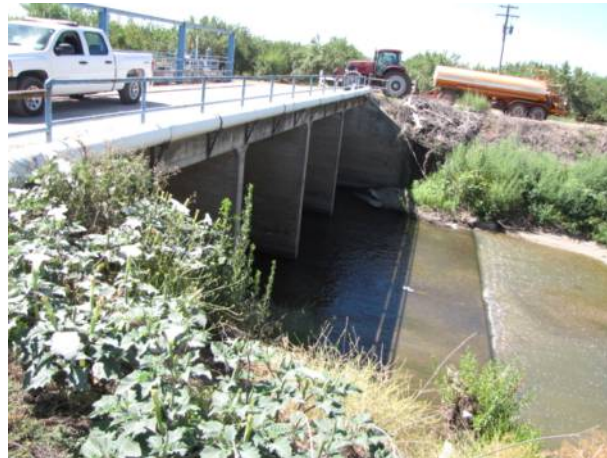
Levee Mile Report Line	16
Start Levee Mile	0.00
End Levee Mile	0.00
Location	
Category	Channels
Item	Vegetation & Obstructions
Looking downstream from Crocker Dam at Back Rascal Creek. Photo taken 7-13-2011.	
phillips_c_20110718_004.jpg

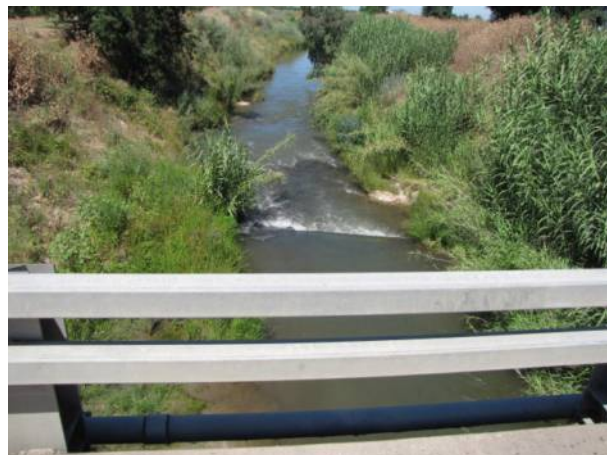
Levee Mile Report Line	26
Start Levee Mile	0.00
End Levee Mile	0.00
Location	
Category	Channels
Item	Vegetation & Obstructions
Looking downstream from Franklin Road crossing at Black Rascal Creek. Photo taken 7-13-2011.	
phillips_c_20110718_006.jpg

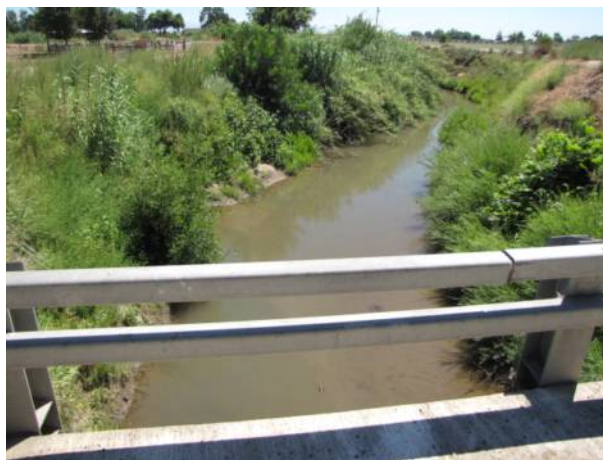
phillips_c_20110718_007.jpg

Looking upstream at Black Rascal Creek from Gurr Road crossing. Photo taken 7-13-2011.

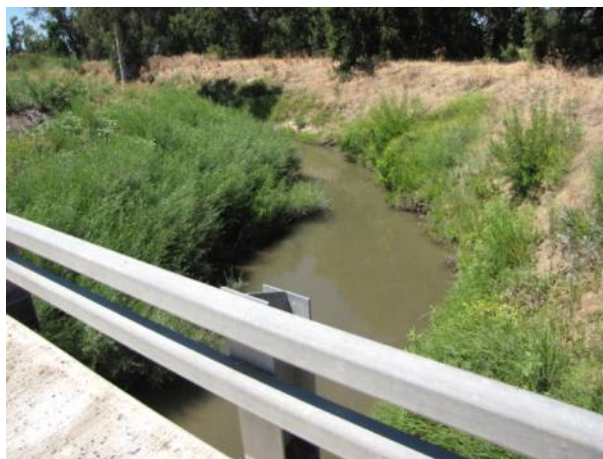
phillips_c_20110718_008.jpg

Looking downstream of Black Rascal Creek from Gurr Road crossing the Black Rascal Creek. Photo taken 7-13-2011.

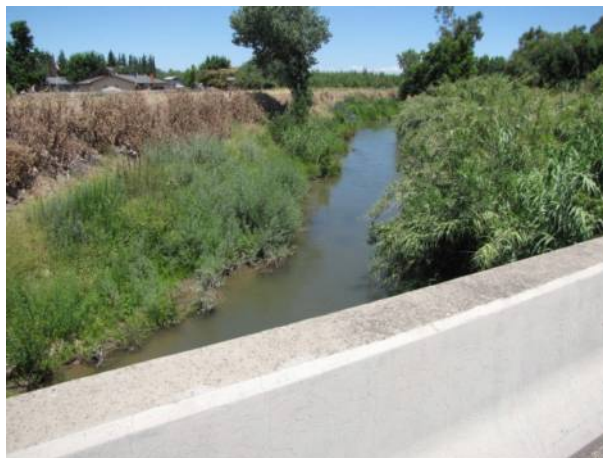
phillips_c_20110718_009.jpg

Looking upstream Hwy 140 crossing the Black Rascal Creek, wild growth shown on both banks. Photo taken 7-13-2011.

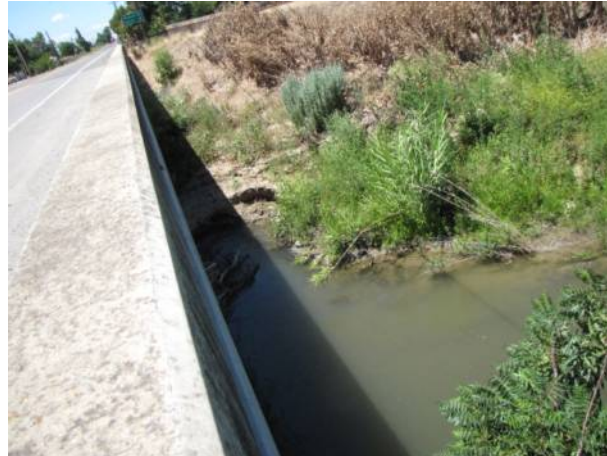
Levee Mile Report Line	43
Start Levee Mile	0.00
End Levee Mile	0.00
Location	
Category	Channels
Item	Erosion / Bank Caving
Looking upstream at erosion rightbank toe of Black Rascal Creek at HWY 140 Bridge crossing. 7-13-2011	
phillips_c_20110718_010.jpg

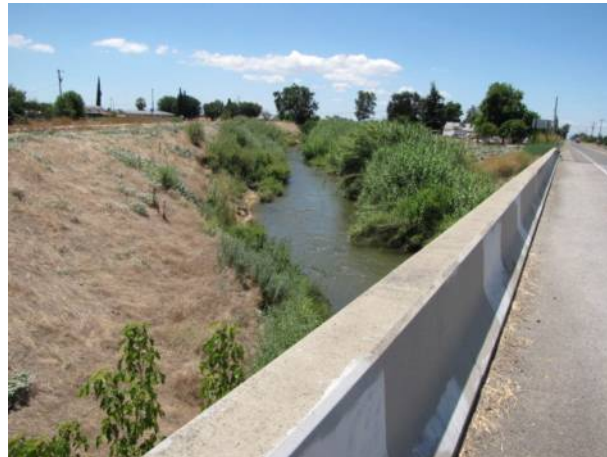
Levee Mile Report Line	46
Start Levee Mile	0.00
End Levee Mile	0.00
Location	
Category	Channels
Item	Vegetation & Obstructions
Looking downstream from Hwy 140 at Black Rascal Creek. 7-13-2011.	
phillips_c_20110718_011.jpg

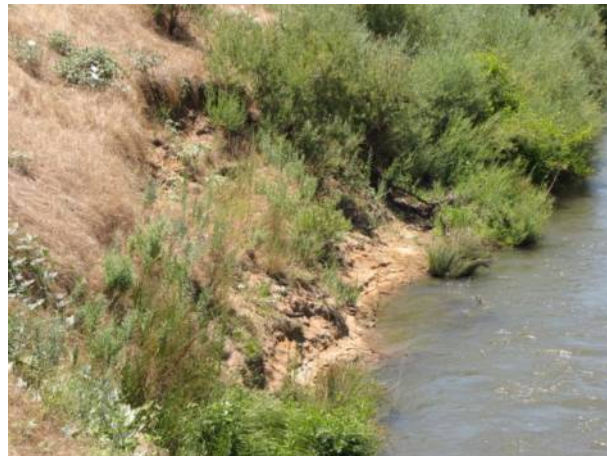
Levee Mile Report Line	48
Start Levee Mile	0.00
End Levee Mile	0.00
Location	
Category	Channels
Item	Erosion / Bank Caving
Erosion exist downstream from Hwy 140 L/B near bridge crossing, there is no riprap present at location. Photo taken 7-13-2011.	
phillips_c_20110727_034.jpg

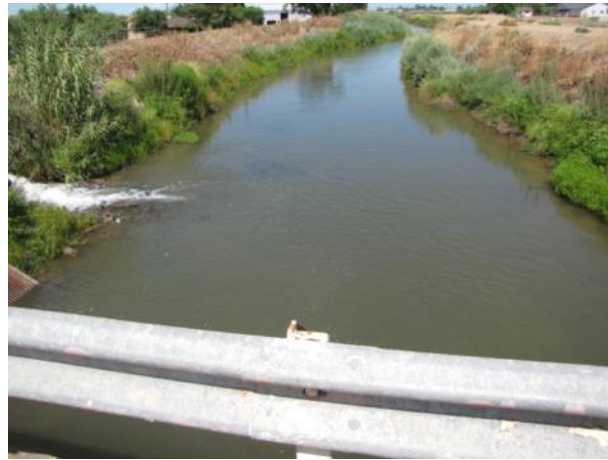
phillips_c_20110727_035.jpg

Looking upstream from Quinley Road crossing at Black Rascal Creek. Photo taken 7-13-2011.

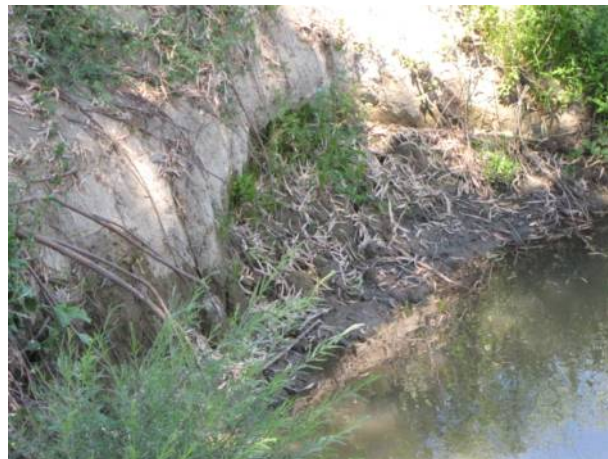
phillips_c_20110727_037.jpg

looking upstream from Quinley Road crossing the Black Rascal Creek upstream R/B, erosion along the bank. 7-13-2011.

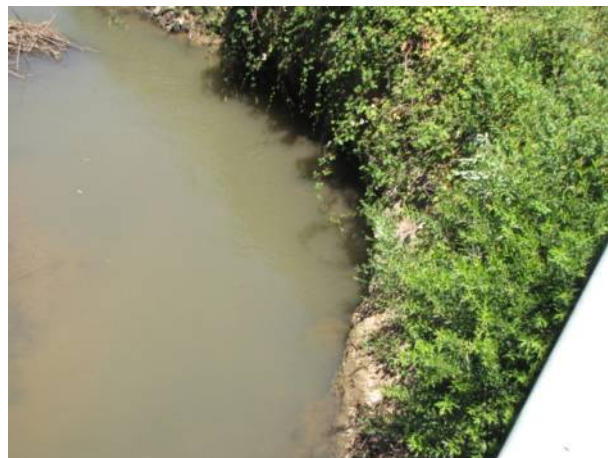
phillips_c_20110727_038.jpg

Erosion present L/B upstream covered up by wild growth. 7-13-2011.

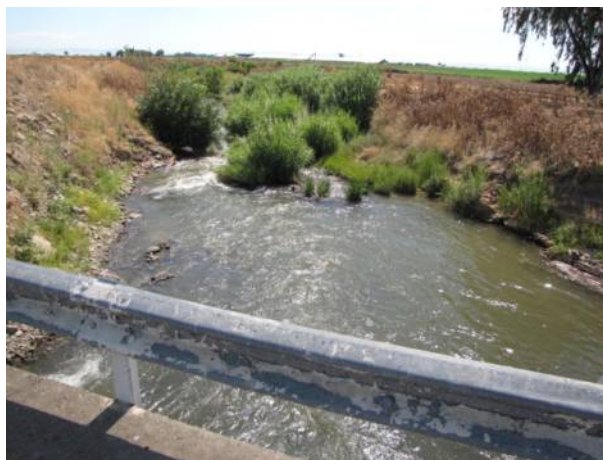
phillips_c_20110727_036.jpg

Looking downstream of Black Rascal Creek channel clear for 100 yards, brush buildup from that point farther downstream. The date of this photo was 7-13-2011.

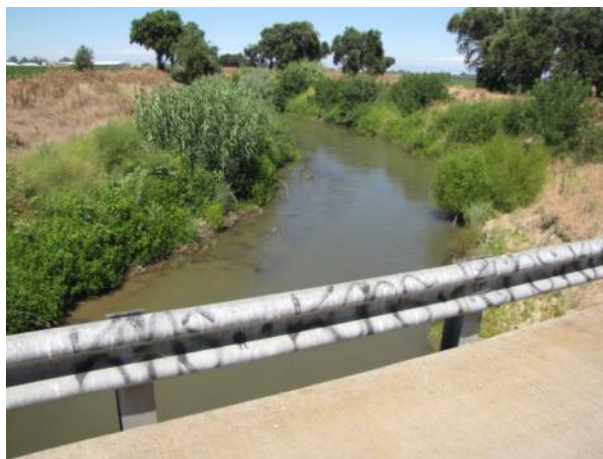
phillips_c_20110727_039.jpg

Looking upstream from Oak Avenue crossing the Black Rascal Creek. Photo taken 7-13-2011.

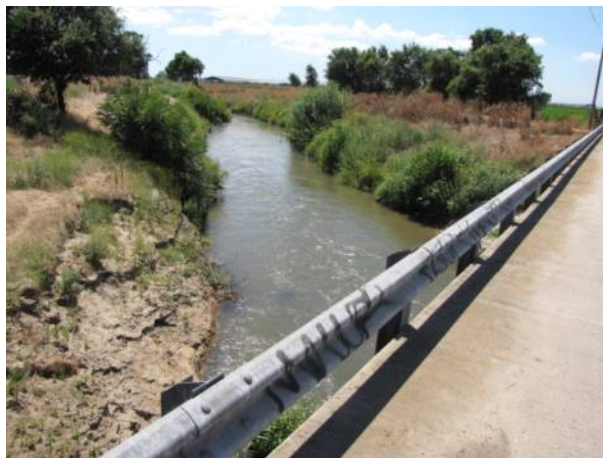
phillips_c_20110809_063.jpg

Standing on Oak Ave. Bridge crossing the Black Rascal Creek looking downstream at channel. Photo taken 7-13-2011.

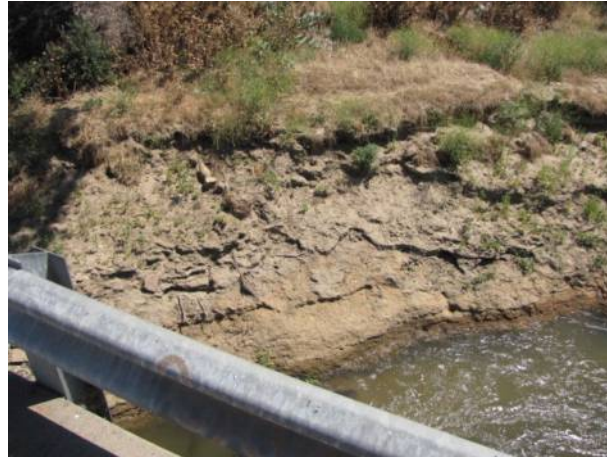
Levee Mile Report Line	68
Start Levee Mile	0.00
End Levee Mile	0.00
Location	
Category	Channels
Item	Erosion / Bank Caving
Looking downstream L/B erosion at Oak Avenue bridge crossing. 7-13-2011.	
phillips_c_20110727_040.jpg

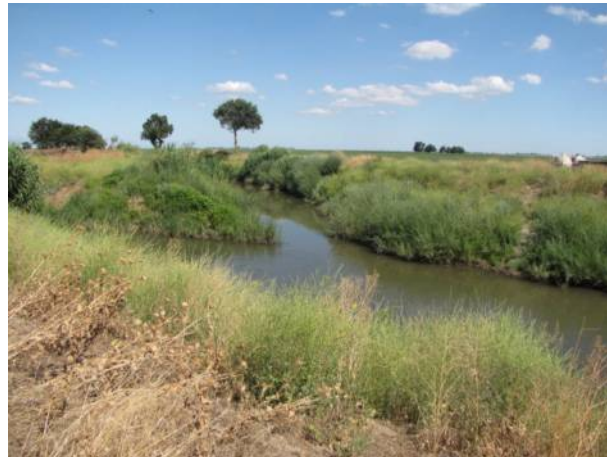
Levee Mile Report Line	71
Start Levee Mile	0.00
End Levee Mile	0.00
Location	
Category	Channels
Item	Vegetation & Obstructions
looking upstream at the confluence of the Bear Creek merging into the Black Rascal Creek. 7-13-2011.	
phillips_c_20110727_041.jpg

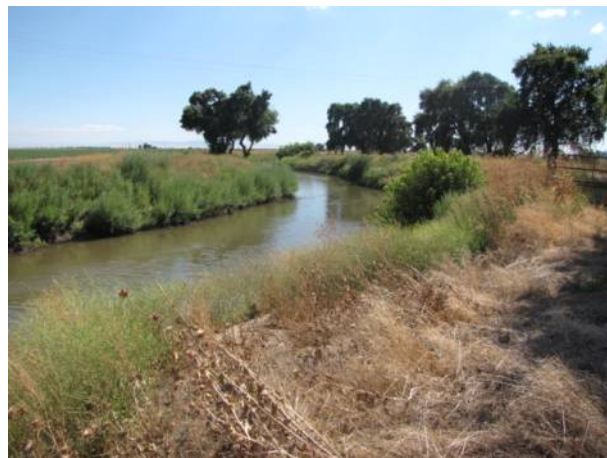
Levee Mile Report Line	76
Start Levee Mile	0.00
End Levee Mile	0.00
Location	
Category	Channels
Item	Vegetation & Obstructions
Looking downstream at Black Rascal Creek down from the confluence. 7-13-2011.	
phillips_c_20110727_042.jpg

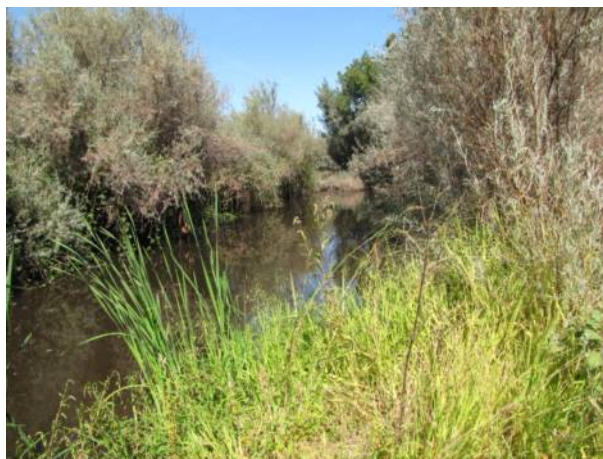
Levee Mile Report Line	6
Start Levee Mile	0.00
End Levee Mile	0.00
Location	
Category	Channels
Item	Vegetation & Obstructions
Standing at low water crossing Burns Creek looking upstream. Photo taken 9-27-2011.	
phillips_c_20110930_120.jpg

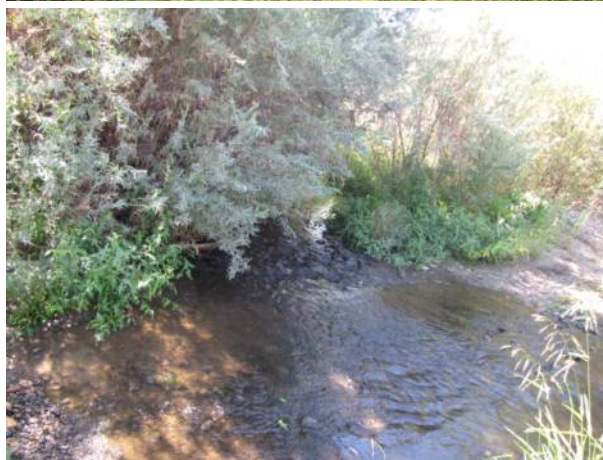
Levee Mile Report Line	11
Start Levee Mile	0.00
End Levee Mile	0.00
Location	
Category	Channels
Item	Vegetation & Obstructions
Standing on left bank of low water crossing looking downstream. Photo taken 9-27-2011.	
phillips_c_20110930_121.jpg

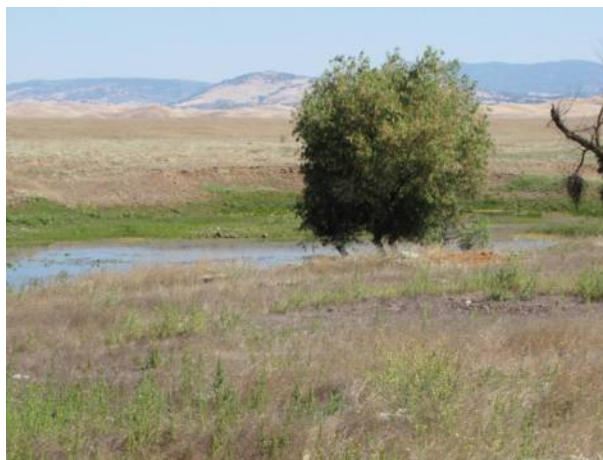
Levee Mile Report Line	1
Start Levee Mile	0.00
End Levee Mile	0.00
Location	
Category	Channels
Item	Vegetation & Obstructions
Standing off White Rock Road looking upstream of Mariposa Creek & Duck Slough. Photo taken 7-19-2011.	
phillips_c_20110722_013.jpg

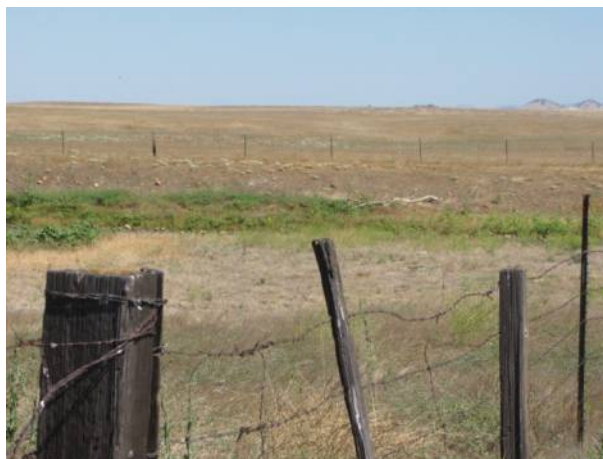
Levee Mile Report Line	6
Start Levee Mile	0.00
End Levee Mile	0.00
Location	
Category	Channels
Item	Vegetation & Obstructions
Standing on White Roack Road looking downstream at Mariposa Creek & Duck Slough looking downstream. 7-19-2011.	
phillips_c_20110722_014.jpg

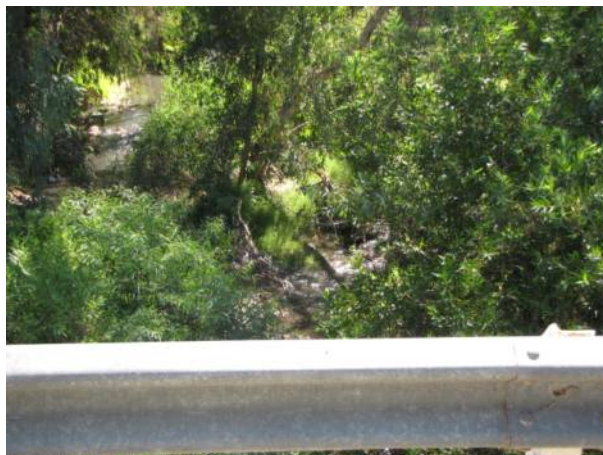
Levee Mile Report Line	11
Start Levee Mile	0.00
End Levee Mile	0.00
Location	
Category	Channels
Item	Vegetation & Obstructions
Standing on Fresno Road looking upstream at Mariposa Creek. Photo taken 7-19-2011.	
phillips_c_20110722_015.jpg

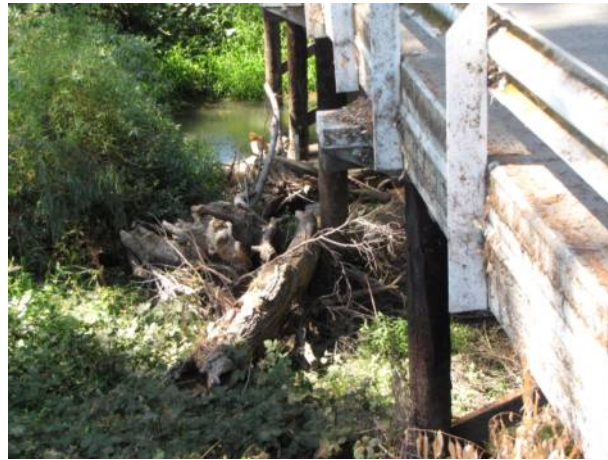
phillips_c_20110719_012.jpg

Levee Mile Report Line	12
Start Levee Mile	0.00
End Levee Mile	0.00
Location	
Category	Channels
Item	Shoaling / Sedimentation

Standing upstream of Fresno bridge crossing Mariposa Creek debris build up against bridge support(bend). Photo taken 7-19-2011.

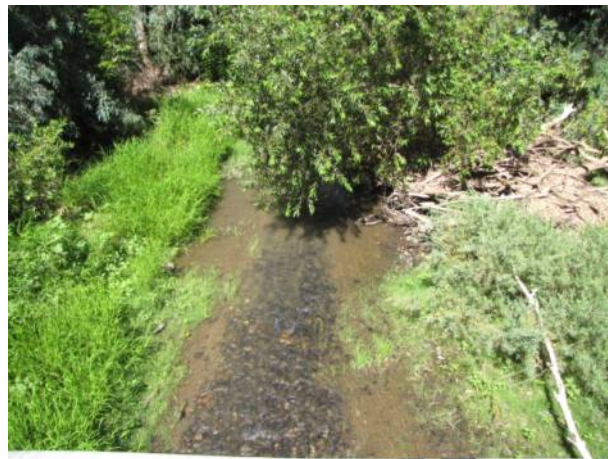
phillips_c_20110722_016.jpg

Levee Mile Report Line	16
Start Levee Mile	0.00
End Levee Mile	0.00
Location	
Category	Channels
Item	Vegetation & Obstructions

Looking down from Fresno Bridge crossing Mariposa Creek. Photo taken 7-19-2011.

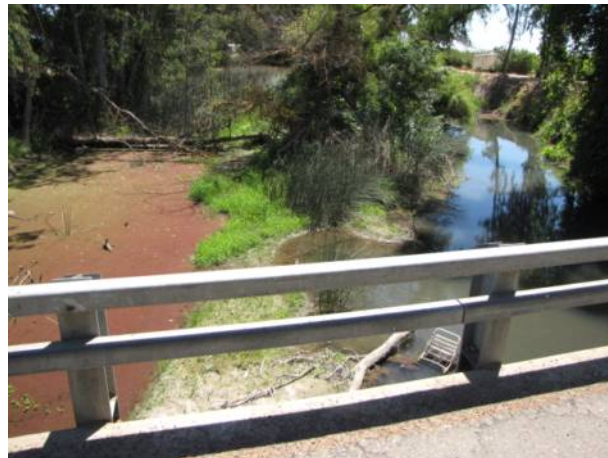
phillips_c_20110722_017.jpg

Levee Mile Report Line	21
Start Levee Mile	0.00
End Levee Mile	0.00
Location	
Category	Channels
Item	Vegetation & Obstructions

Looking upstream from Cunningham Road at Mariposa Creek.

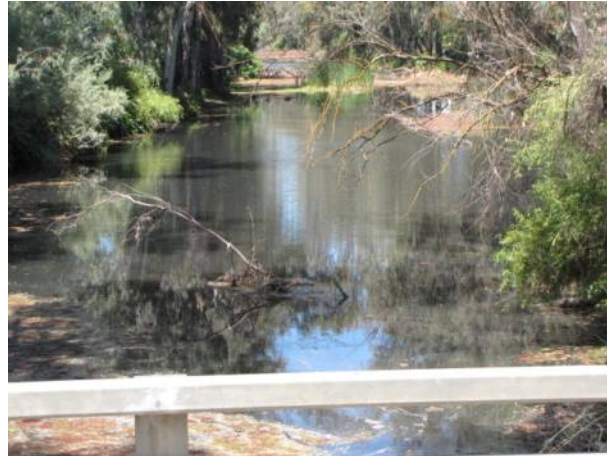
phillips_c_20110725_018.jpg

Levee Mile Report Line	26
Start Levee Mile	0.00
End Levee Mile	0.00
Location	
Category	Channels
Item	Vegetation & Obstructions

Looking downstream from Cunningham road bridge crossing at channel. Photo taken 7-19-2011.

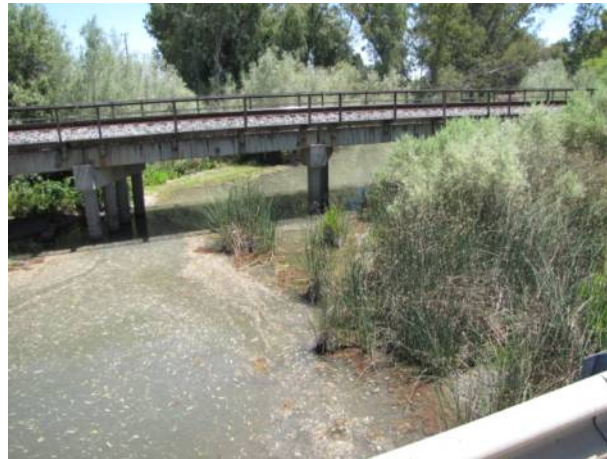
phillips_c_20110725_019.jpg

Levee Mile Report Line	31
Start Levee Mile	0.00
End Levee Mile	0.00
Location	
Category	Channels
Item	Vegetation & Obstructions

From Hwy 140 looking upstream. Photo taken 7-19-2011.

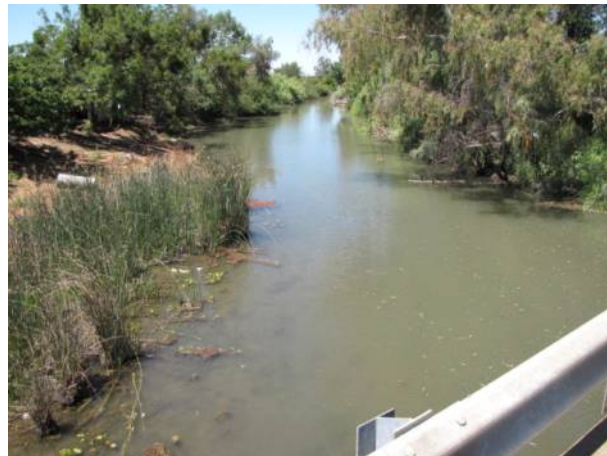
phillips_c_20110725_020.jpg

Levee Mile Report Line	36
Start Levee Mile	0.00
End Levee Mile	0.00
Location	
Category	Channels
Item	Vegetation & Obstructions

Looking downstream from Hwy 140 bridge crossing the Mariposa Creek. Photo taken 7-19-2011.

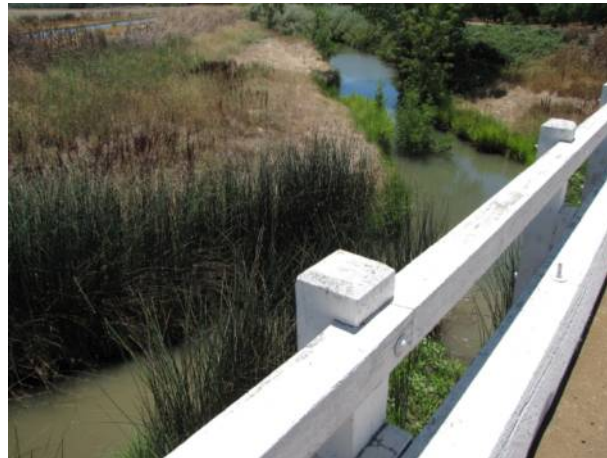
Levee Mile Report Line	41
Start Levee Mile	0.00
End Levee Mile	0.00
Location	
Category	Channels
Item	Vegetation & Obstructions
<p>From Burchell Rd looking upstream at Mariposa Creek, Owens Creek runs into Mariposa Creek at this location. Photo taken 7-19-2011.</p> <p>phillips_c_20110725_021.jpg</p>

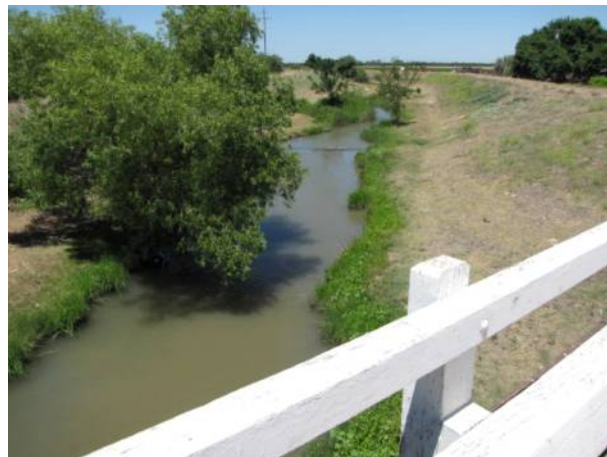
Levee Mile Report Line	46
Start Levee Mile	0.00
End Levee Mile	0.00
Location	
Category	Channels
Item	Vegetation & Obstructions
<p>Looking downstream from Burchell Rd crossing the Mariposa Creek. Photo taken 7-19-2011.</p> <p>phillips_c_20110725_022.jpg</p>

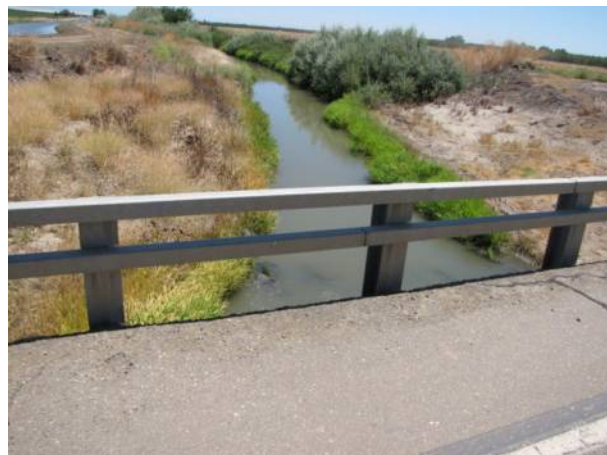
Levee Mile Report Line	51
Start Levee Mile	0.00
End Levee Mile	0.00
Location	
Category	Channels
Item	Vegetation & Obstructions
<p>Plainsburg Rd crossing Mariposa Creek looking upstream. Photo taken 7-19-2011</p> <p>phillips_c_20110725_023.jpg</p>

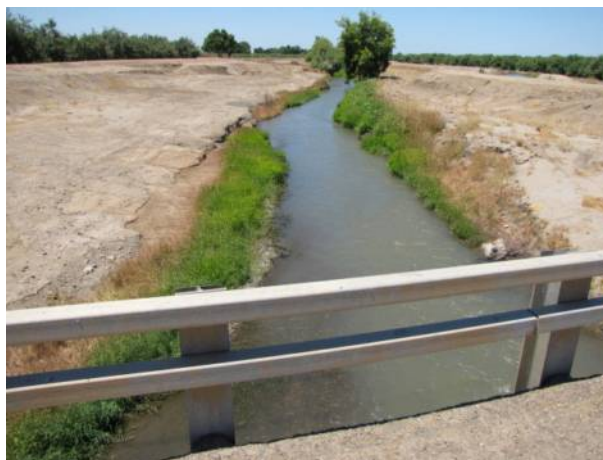
Levee Mile Report Line	56
Start Levee Mile	0.00
End Levee Mile	0.00
Location	
Category	Channels
Item	Vegetation & Obstructions
Plainsburg Rd. crossing Mariposa Creek looking downstream. Photo taken 7-19-2011	
phillips_c_20110725_024.jpg

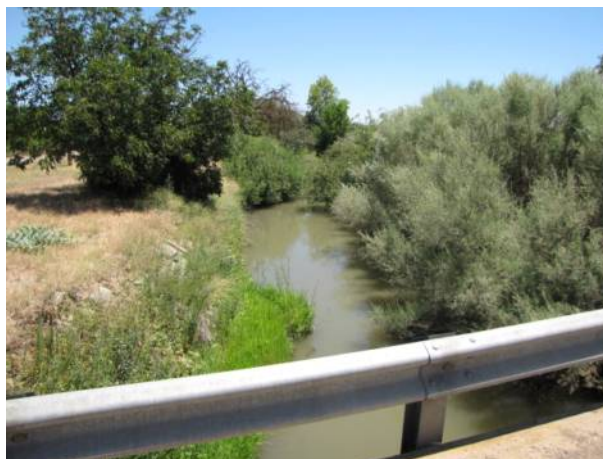
Levee Mile Report Line	61
Start Levee Mile	0.00
End Levee Mile	0.00
Location	
Category	Channels
Item	Vegetation & Obstructions
From Whealan Rd. looking upstream. Photo taken 7-19-2011.	
phillips_c_20110726_025.jpg

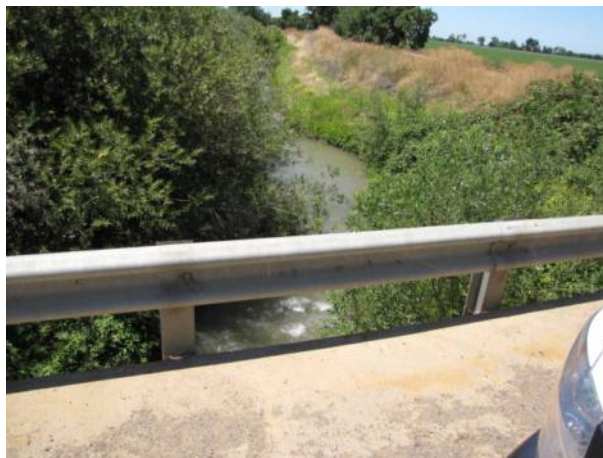
Levee Mile Report Line	66
Start Levee Mile	0.00
End Levee Mile	0.00
Location	
Category	Channels
Item	Vegetation & Obstructions
Looking downstream from whealan road at Mariposa Creek. Photo taken 7-19-2011.	
phillips_c_20110726_026.jpg

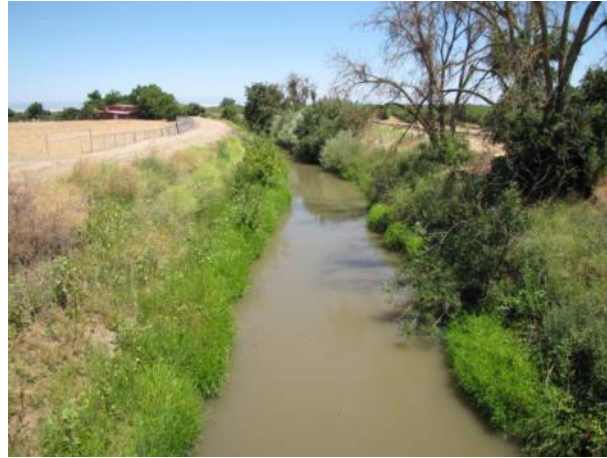
Levee Mile Report Line	71
Start Levee Mile	0.00
End Levee Mile	0.00
Location	
Category	Channels
Item	Vegetation & Obstructions
Upstream of Arboleda Road crossing the Mariposa Creek/Duck Slough. 7-19-2011.	
phillips_c_20110726_027.jpg

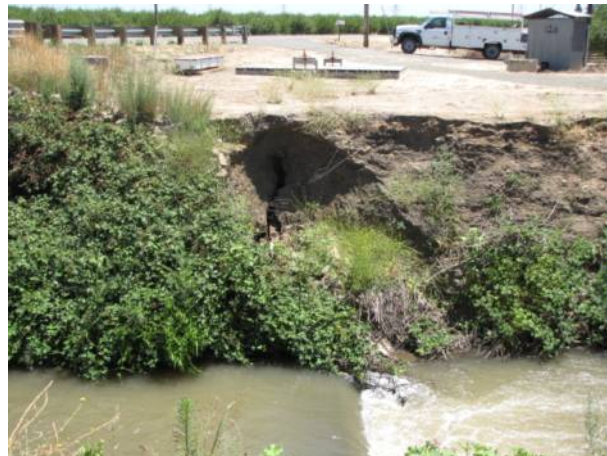
Levee Mile Report Line	78
Start Levee Mile	0.00
End Levee Mile	0.00
Location	
Category	Channels
Item	Erosion / Bank Caving
Erosion exist on L/B slope of the Mariposa creek downstream from Arboleda road crossing, 37.25690 -120.37947. 7-19-2011.	
phillips_c_20110726_029.jpg

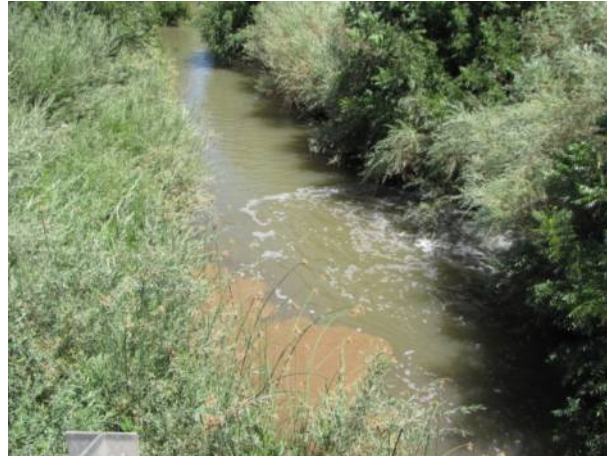
Levee Mile Report Line	81
Start Levee Mile	0.00
End Levee Mile	0.00
Location	
Category	Channels
Item	Vegetation & Obstructions
Upstream of Mariposa Creek Healy road crossing. Photo taken 7-19-2011.	
phillips_c_20110726_030.jpg

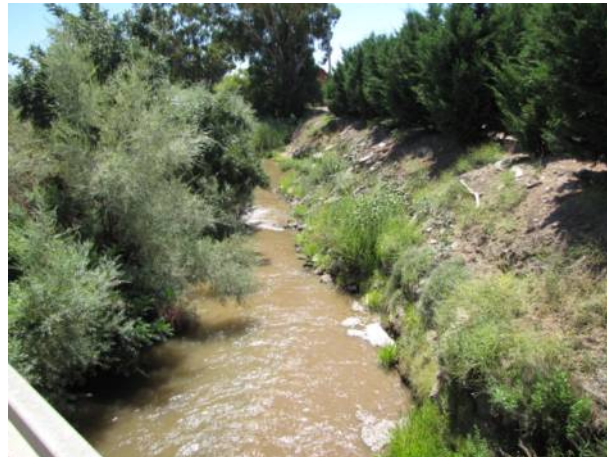
Levee Mile Report Line	86
Start Levee Mile	0.00
End Levee Mile	0.00
Location	
Category	Channels
Item	Vegetation & Obstructions
Mariposa Creek downstream from Healy Rd. Photo taken 7-19-2011.	
phillips_c_20110726_031.jpg

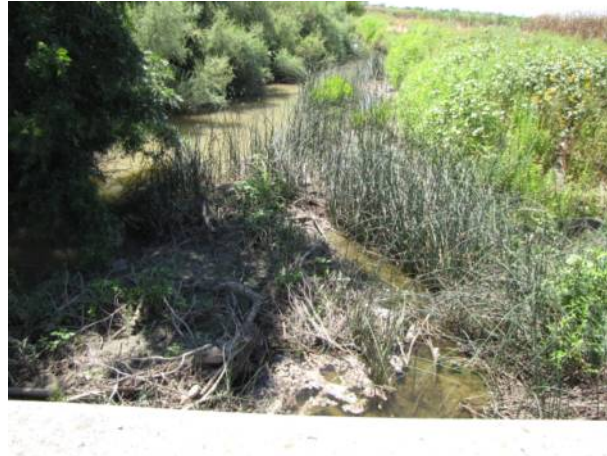
Levee Mile Report Line	96
Start Levee Mile	0.00
End Levee Mile	0.00
Location	
Category	Channels
Item	Vegetation & Obstructions
Downstream from Hwy 59 crossing Mariposa Creek. Photo taken 7-19-2011.	
phillips_c_20110726_033.jpg

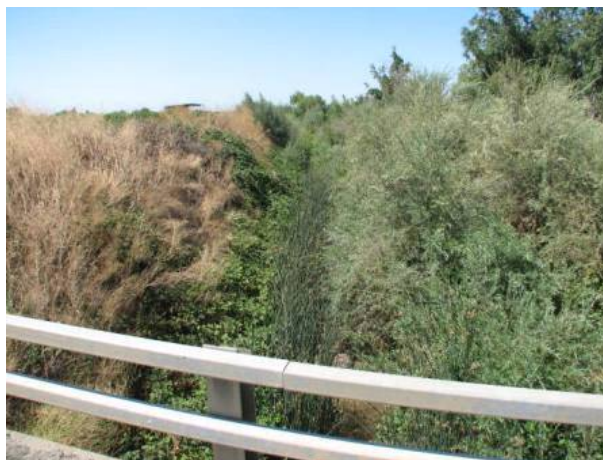
jeto_c_20110802_017.jpg

08/02/2011 Santa Fe Dr. crossing downstream view, note woody vegetation on right side of channel.

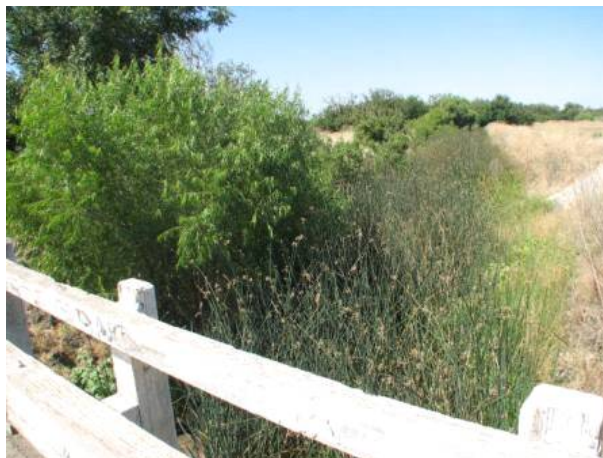
jeto_c_20110802_019.jpg

Levee Mile Report Line	26
Start Levee Mile	0.00
End Levee Mile	0.00
Location	
Category	Channels
Item	Vegetation & Obstructions

08/02/2011 Plainsburg Rd crossing, downstream view, Note woody vegetation on left side of channel.

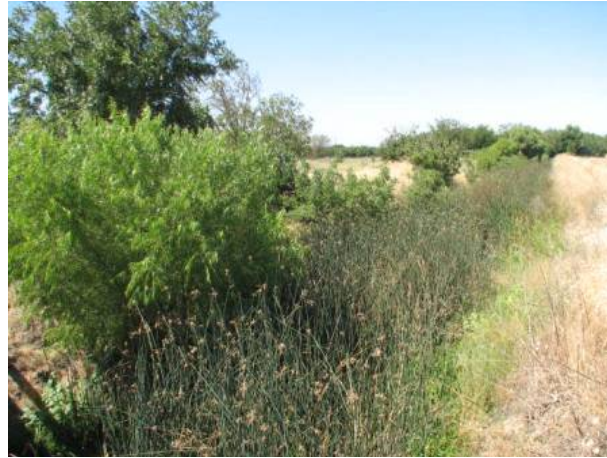
Levee Mile Report Line	26
Start Levee Mile	0.00
End Levee Mile	0.00
Location	
Category	Channels
Item	Vegetation & Obstructions
08/02/2011 Tree growing in channel downstream of Plainsburg Rd. crossing	
jeto_c_20110802_020.jpg

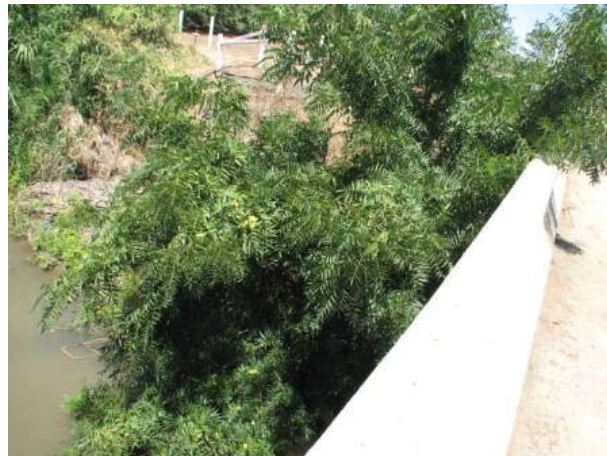
Levee Mile Report Line	106
Start Levee Mile	0.00
End Levee Mile	0.00
Location	
Category	Channels
Item	Vegetation & Obstructions
08/02/2011 Tree growing in channel on downstream side of Highway 59 crossing.	
jeto_c_20110802_037.jpg

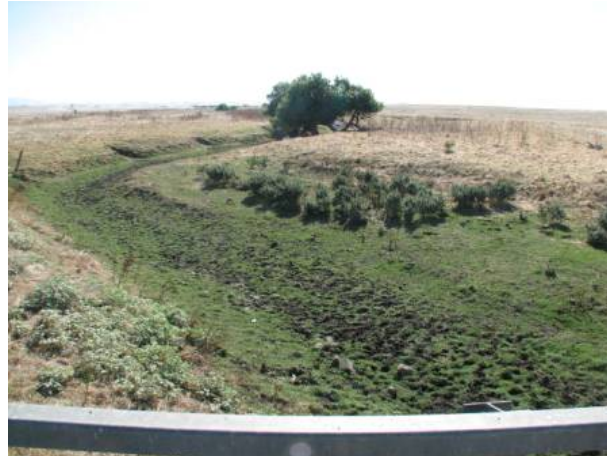
Levee Mile Report Line	1
Start Levee Mile	0.00
End Levee Mile	0.00
Location	
Category	Channels
Item	Vegetation & Obstructions
08/02/2011 Upstream view from Cunningham Road crossing.	
jeto_c_20110802_001.jpg

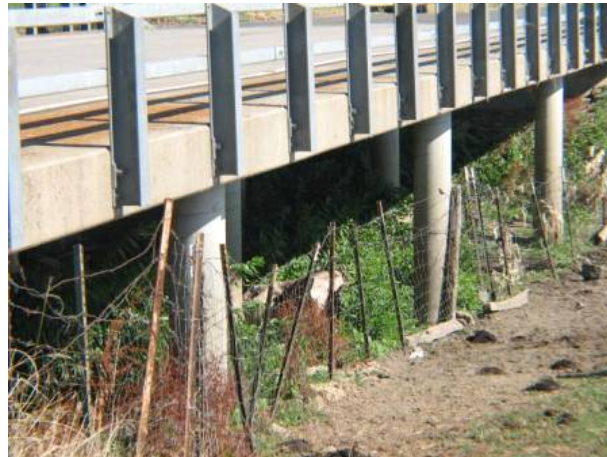
Levee Mile Report Line	5
Start Levee Mile	0.00
End Levee Mile	0.00
Location	
Category	Channels
Item	Encroachments
08/02/2011 Wire fence on upstream side of Cunningham crossing.	
jeto_c_20110802_002.jpg

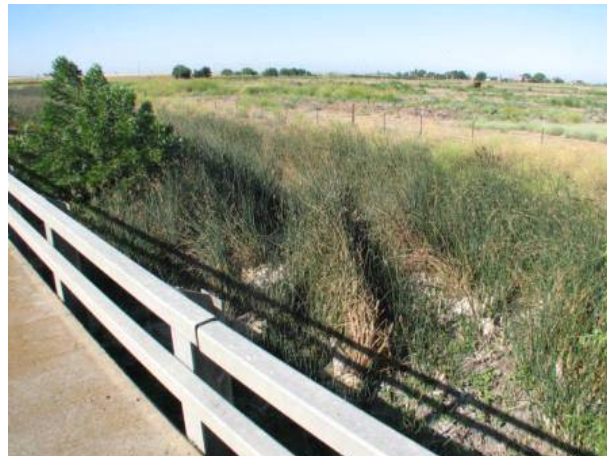
Levee Mile Report Line	6
Start Levee Mile	0.00
End Levee Mile	0.00
Location	
Category	Channels
Item	Vegetation & Obstructions
08/02/2011 Cunningham crossing downstream view.	
jeto_c_20110802_003.jpg

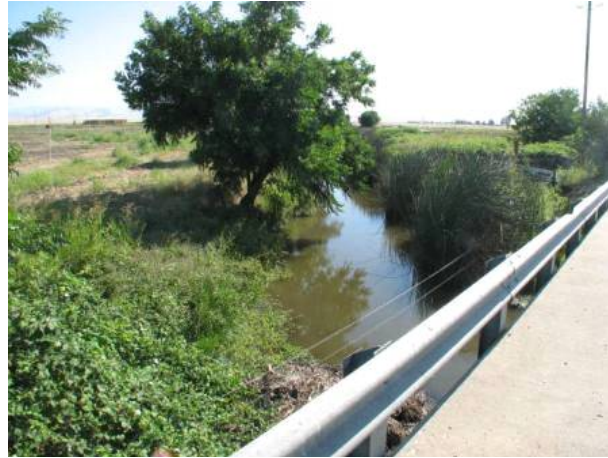
Levee Mile Report Line	11
Start Levee Mile	0.00
End Levee Mile	0.00
Location	
Category	Channels
Item	Vegetation & Obstructions
08/02/2011 Upstream view Childs Ave. crossing.	
jeto_c_20110802_004.jpg

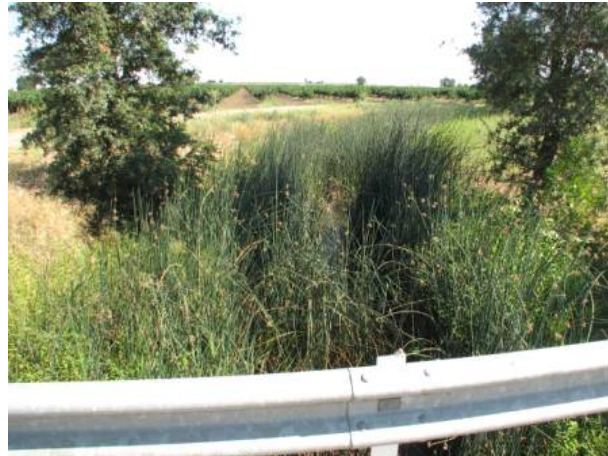
Levee Mile Report Line	21
Start Levee Mile	0.00
End Levee Mile	0.00
Location	
Category	Channels
Item	Vegetation & Obstructions
08/02/2011 Upstream view from Mission Ave. crossing.	
jeto_c_20110802_006.jpg

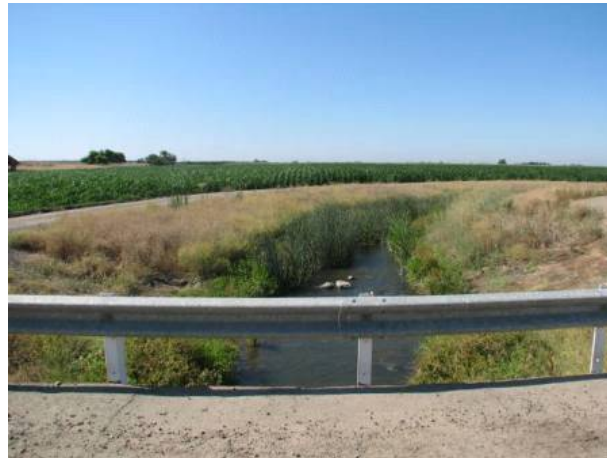
Levee Mile Report Line	28
Start Levee Mile	0.00
End Levee Mile	0.00
Location	
Category	Channels
Item	Erosion / Bank Caving
08/02/2011 Downstream view from Mission Ave. crossing.	
jeto_c_20110802_007.jpg

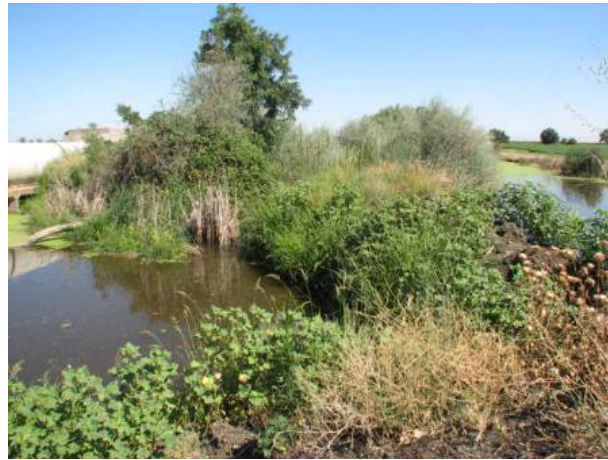
jeto_c_20110802_011.jpg

08/02/2011 Photo shows what appears to be material placed in the channel, material is overgrown with vegetation, "Fresh" material can be seen on the right side of the photo.
